# **Debris/Ice/TPS Assessment and Integrated Photographic Analysis of Shuttle Mission STS-106**

**DEBRIS/ICE/TPS ASSESSMENT  
AND  
INTEGRATED PHOTOGRAPHIC ANALYSIS  
OF  
SHUTTLE MISSION STS-106**

**8 September 2000**

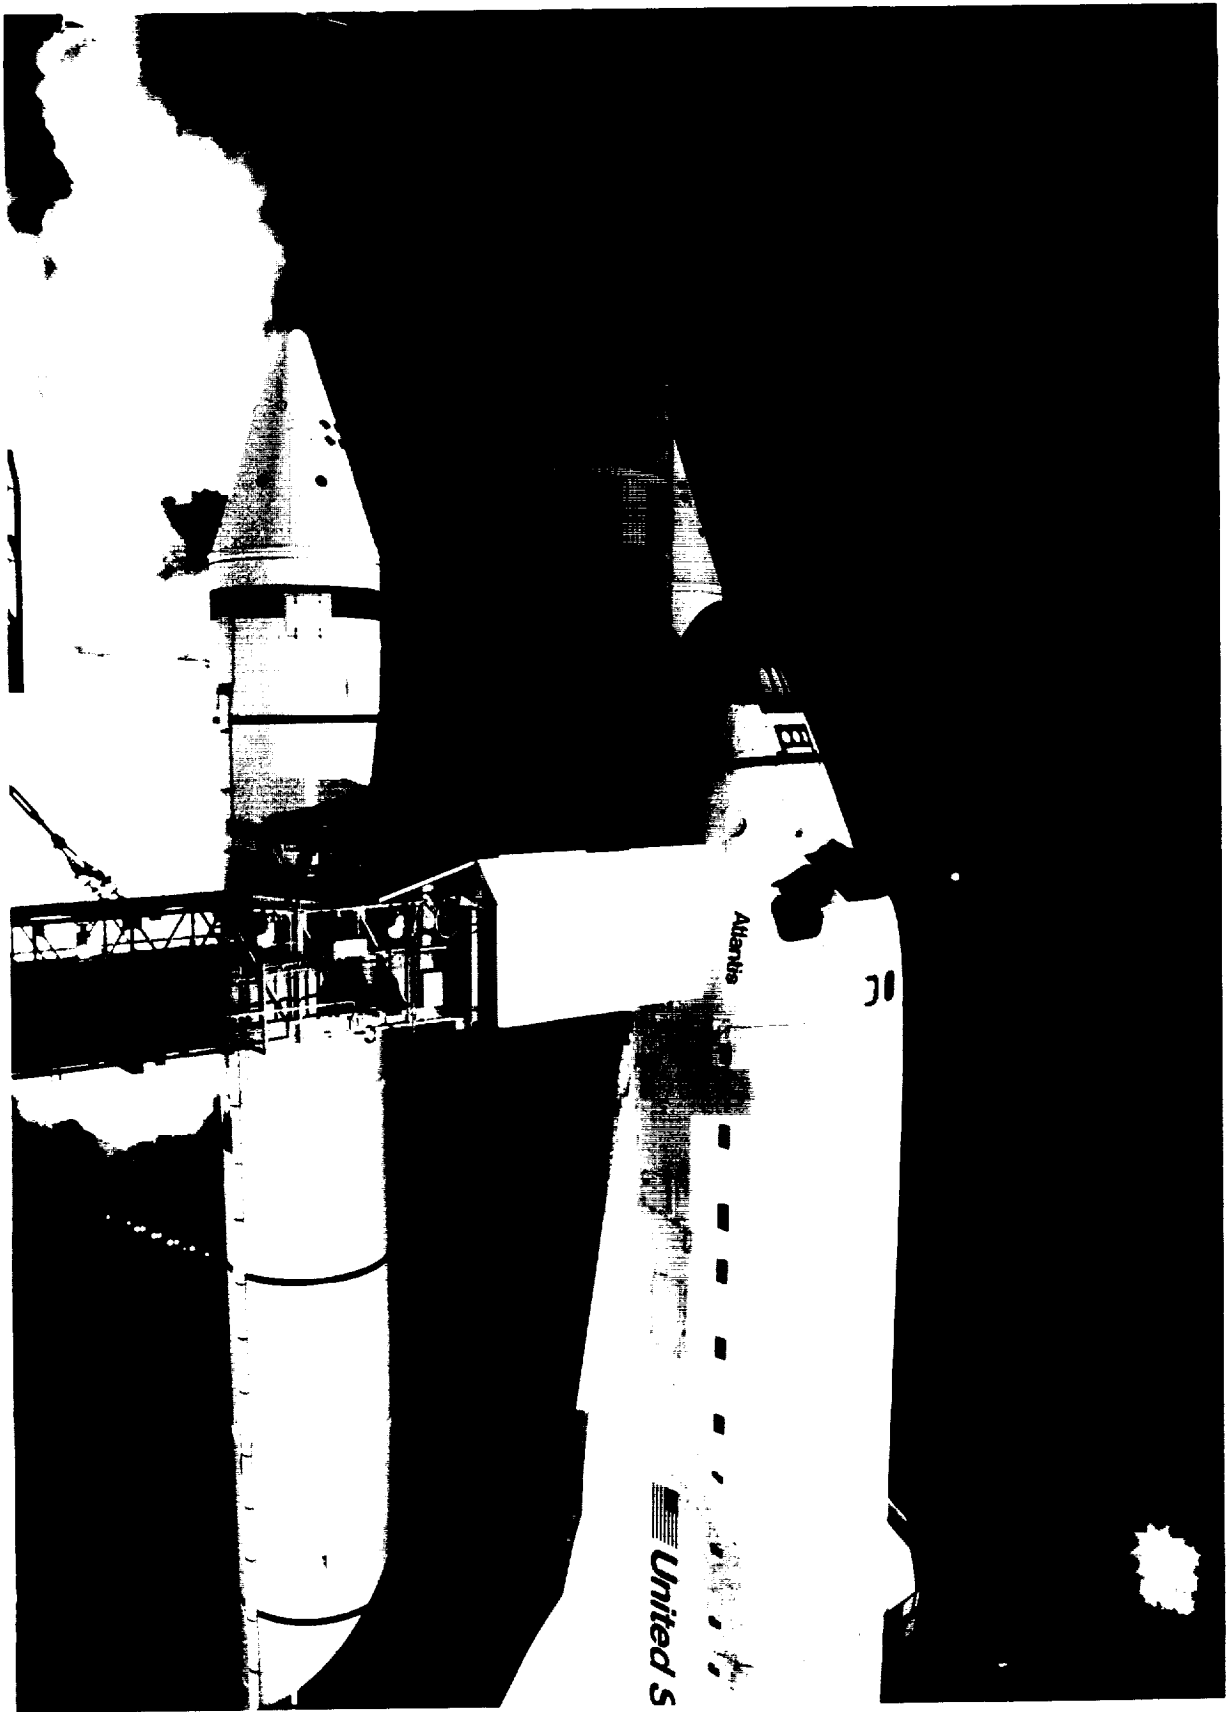
**Photo 2: ET LO2 Tank and Intertank**

The Final Inspection Team observed light condensate on the LO2 tank acreage. Surface temperatures ranged from 62 to 68 degrees F. There were no TPS anomalies. No significant anomalies were present in the intertank TPS and no cracks in stringer valley TPS were detected.

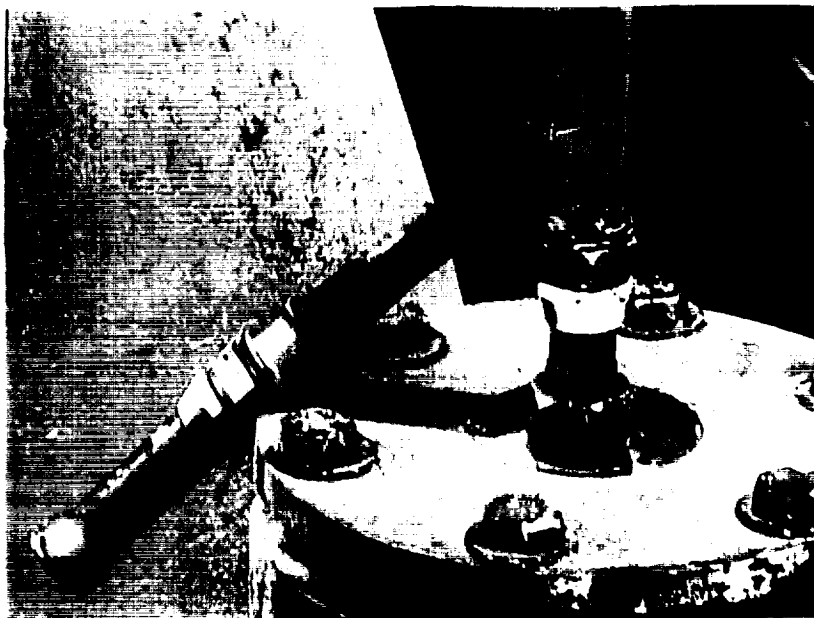
**Photo 6: Aft Skirt GN2 Purge Lines**

Both SRB aft skirt GN2 purge lines were damaged. The LH side was severed and found on the haunch near the base of holddown post #6. The RH side purge line was broken but remained attached by the flex line braided shield. No protective tape remained on either purge flex line. The condition of the lines was an unexpected finding since corrective action had been taken after the failure (severance) of both purge lines on the STS-87 launch. The corrective action consisted of wrapping each line with three layers of blast tape for added thermal protection. Corrective action for STS-92 will consist of wrapping each line with six layers of metallic tape rather than three layers used previously to prolong time the metal braid is protected from melting.

Both SRB aft skirt GN2 purge lines were damaged. The LH side was severed and found on the haunch near the base of holddown post #6. The RH side purge line was broken but remained attached by the flex line braided shield. No protective tape remained on either purge flex line. The condition of the lines was an unexpected finding since corrective action had been taken after the failure (severance) of both purge lines on the STS-87 launch.

The GN2 purge lines separated cleanly from both SRB aft skirts at liftoff. The purge lines were visible for about two seconds after T-0. No anomalies were observed at this time. However, the post launch pad inspection later found the RH purge line hanging by a few metal wire strands while the LH purge line was completely severed and lying on the HDP #6 haunch (E-8, -13).

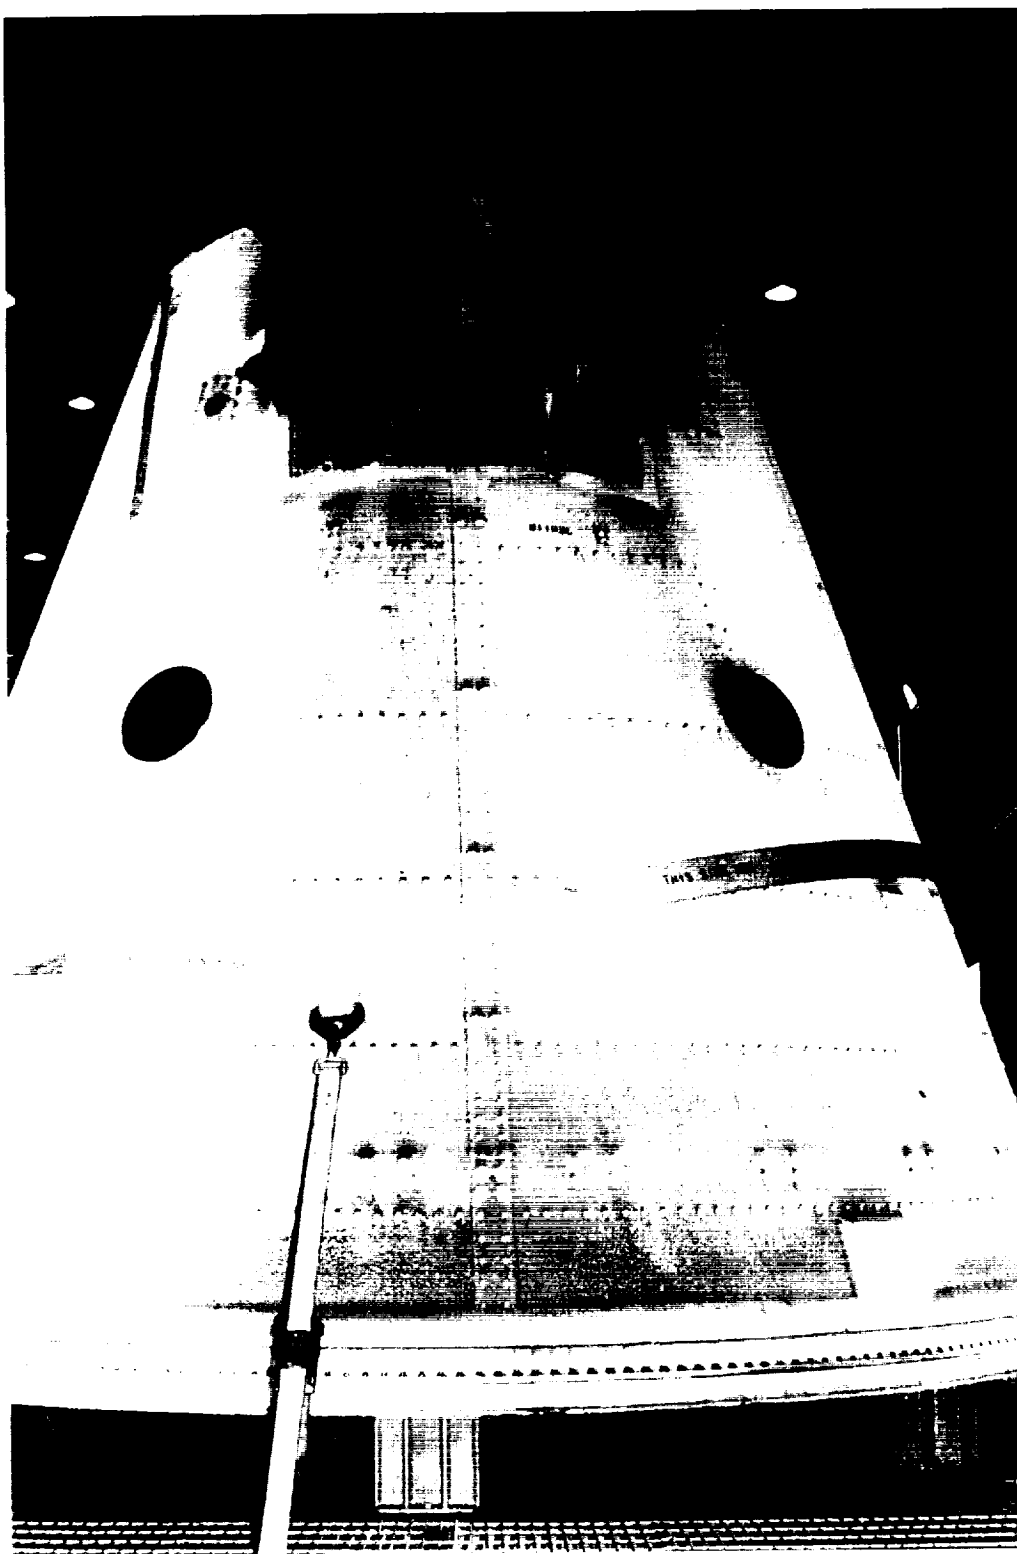
**Photo 15: Frustum Post Flight Condition**

The TPS on both frustums exhibited no debonds/unbonds. All eight BSM aero heat shield covers had fully opened at SRB separation as evidenced by cover contact marks on the nozzles. However, numerous covers and attach rings had been bent by parachute riser entanglement.

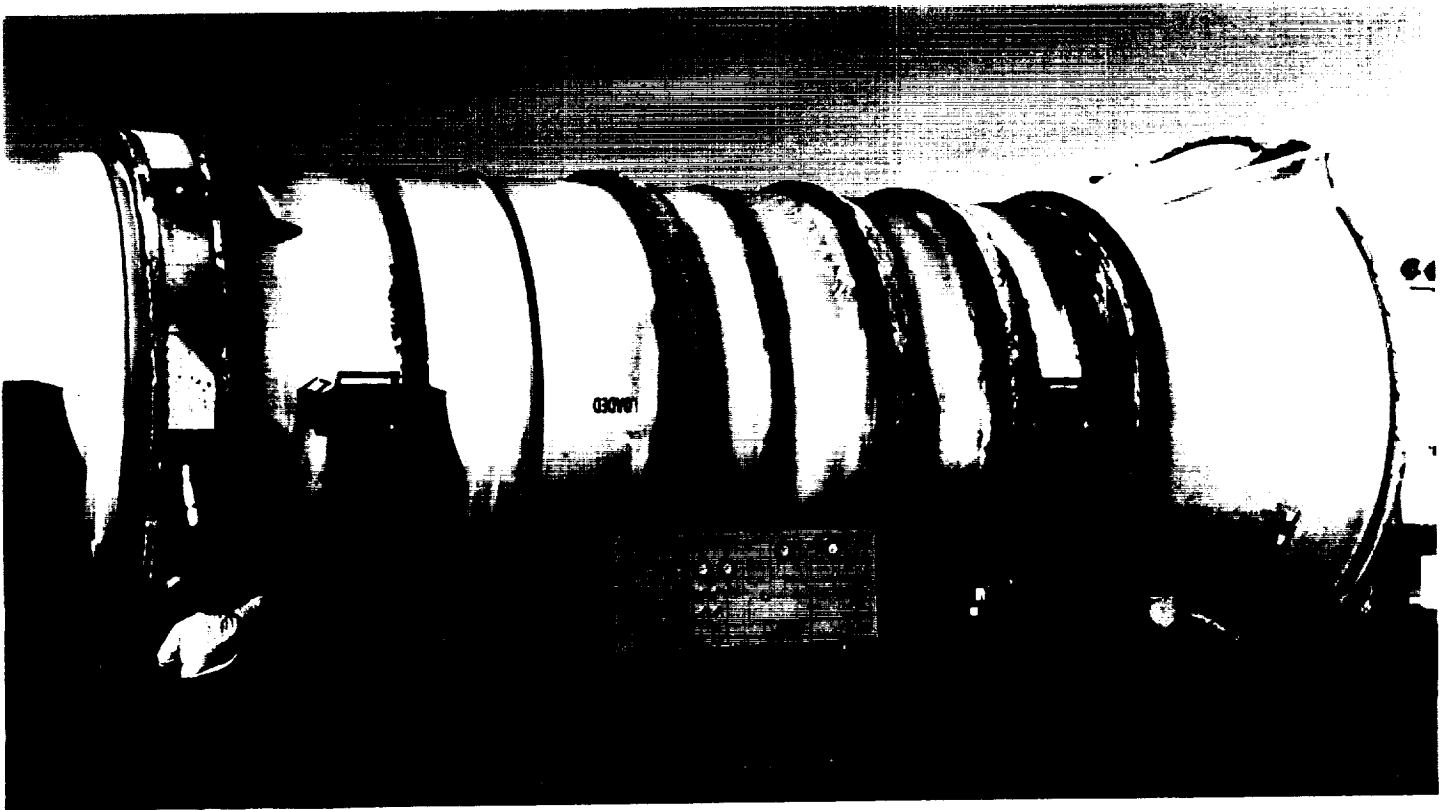
**Photo 17: Aft Skirt Post Flight Condition**

Separation of the aft ET/SRB struts appeared normal. Aft skirt external surface TPS was in good condition. Typical blistering of Hypalon paint had occurred on the BTA insulation closeouts.

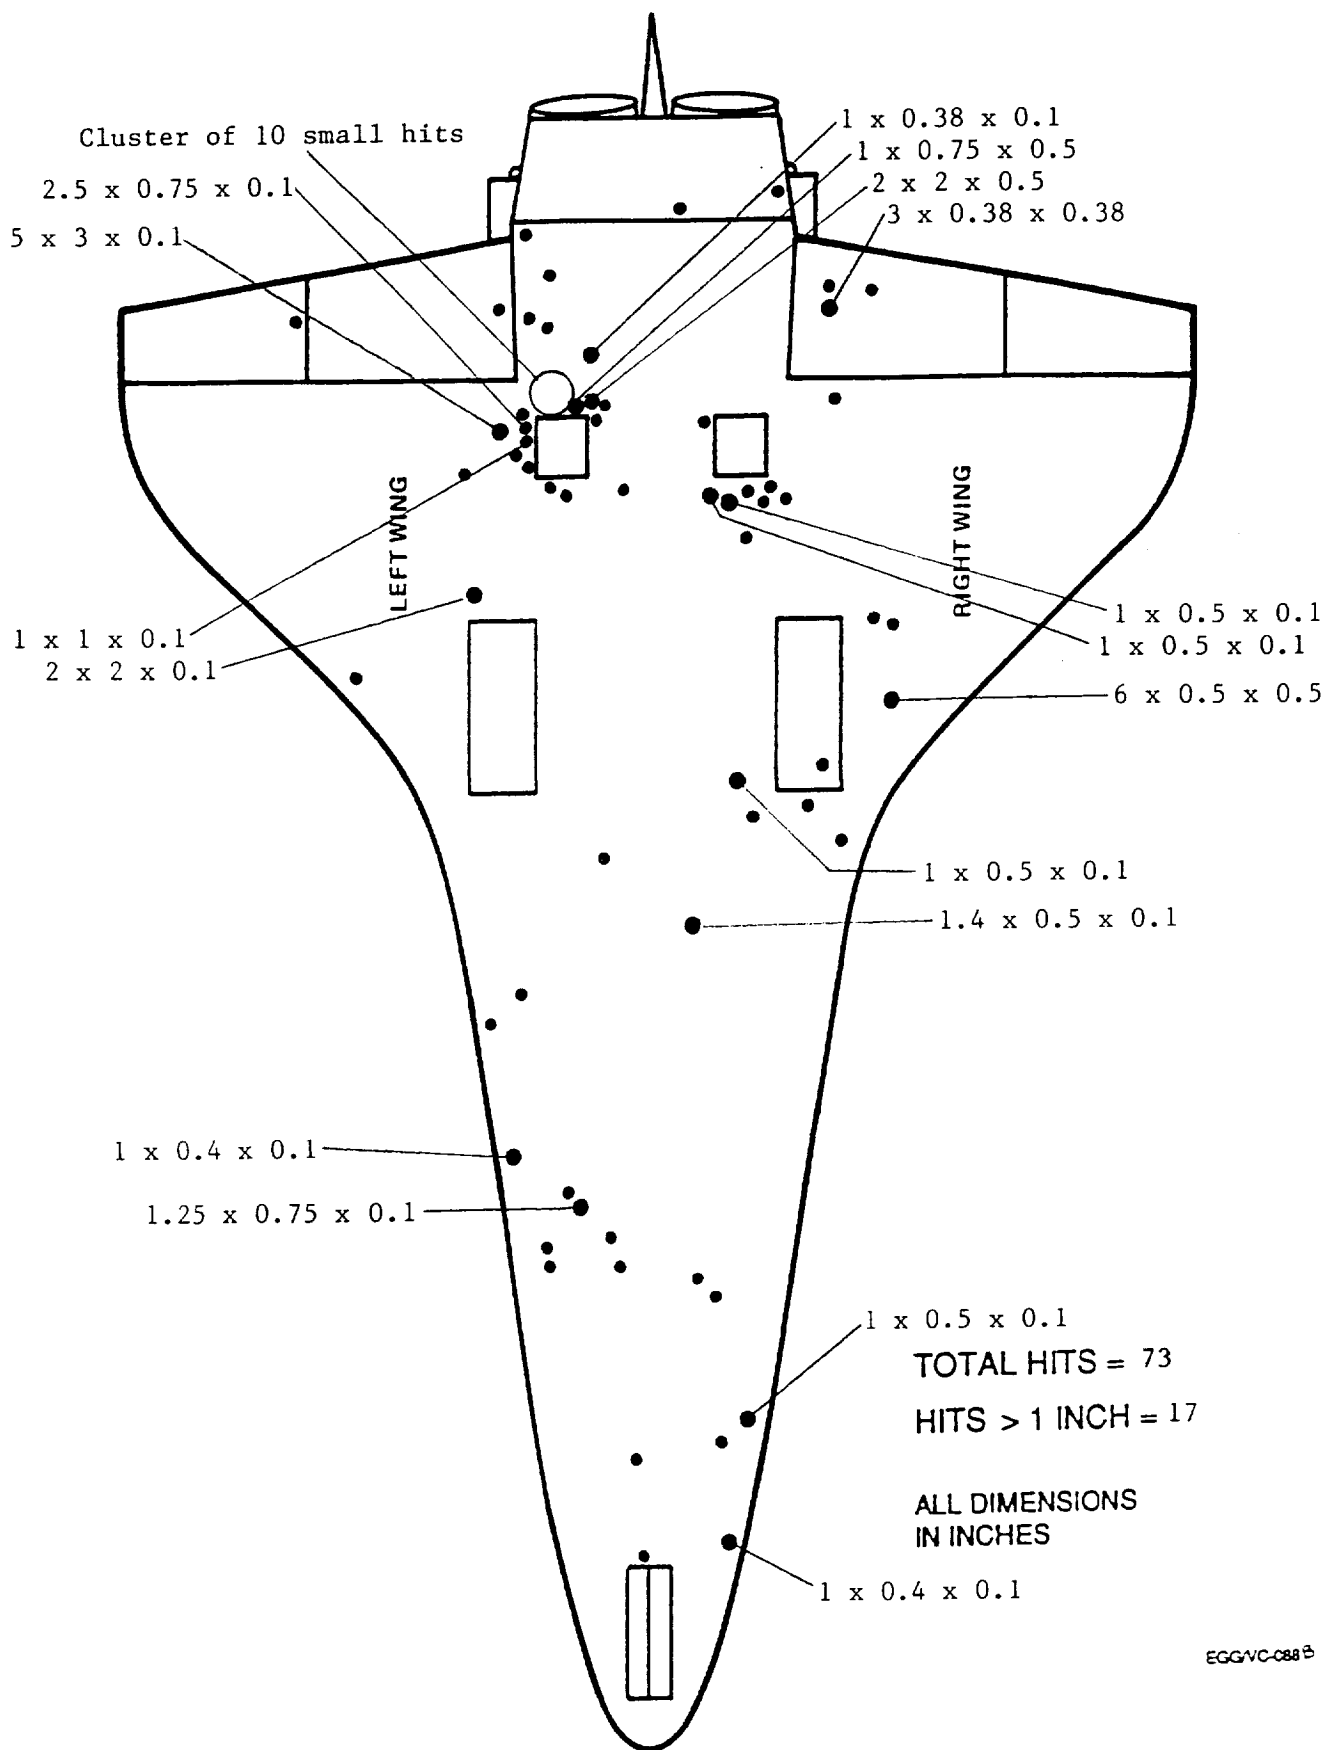
Figure 1: Orbiter Lower Surface Debris Damage Map

The Orbiter lower surface sustained 73 total hits, of which 17 had a major dimension of 1-inch or larger. Approximately 20 damage sites (with five larger than 1-inch in length) were located in the area from the nose gear to the main landing gear wheel wells on both left and right chines consistent with the loss of foam from the ET thrust panels. The quantity and average size of the damage sites compared to previous flights were considerably reduced as a result of the pre-launch TPS venting modification. And some of these hits may be attributed to impacts from ice in the LO2 feedline bellows. In general, the lower surface tile damage on this flight is considered much improved.

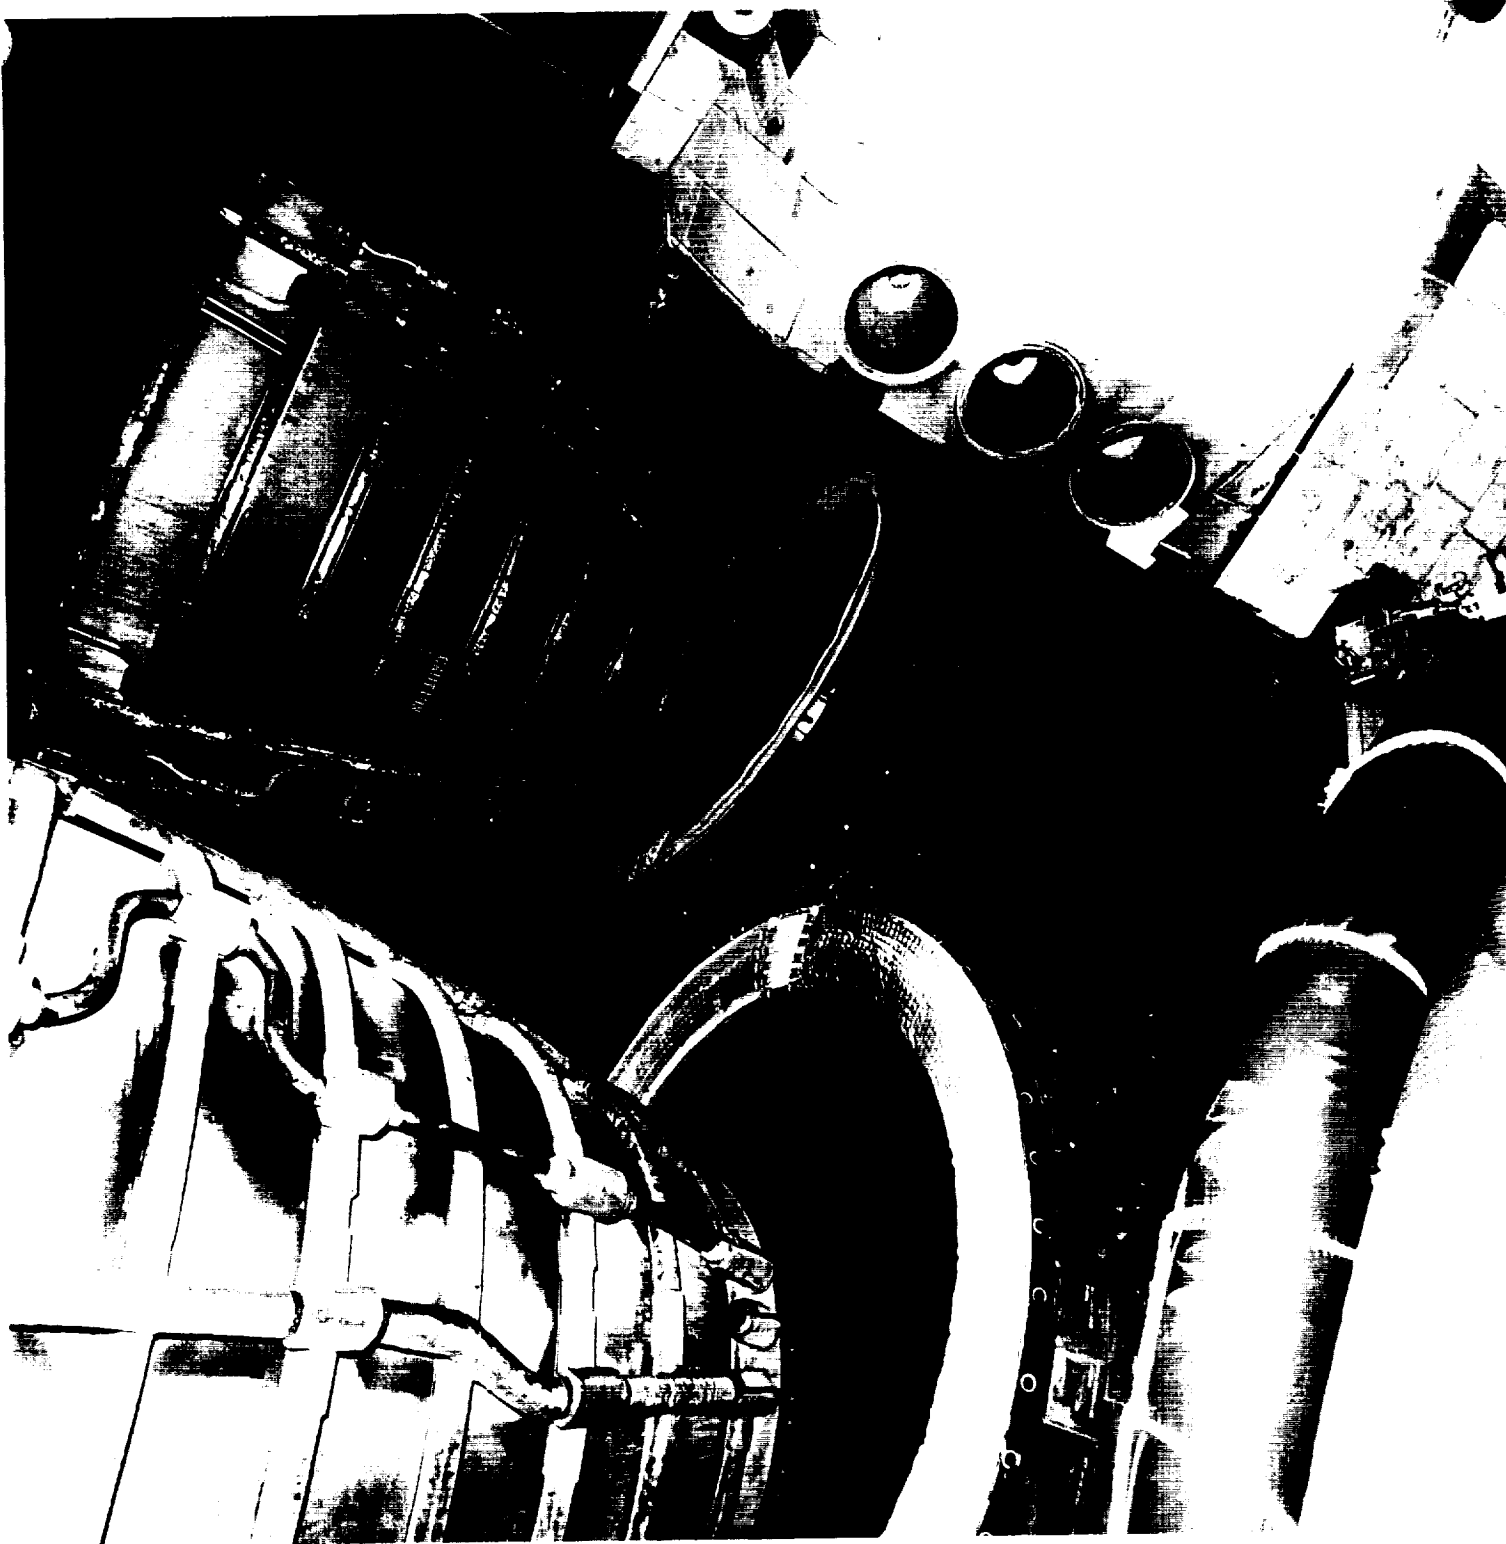
**Photo 20: Base Heat Shield**

Less than usual amounts of tile damage occurred on the base heat shield. All SSME Dome Heat Shield closeout blankets were in excellent condition, though there was some slight fraying of the material on SSME #1 6:00 o'clock position and SSME #3 9:00 o'clock position.

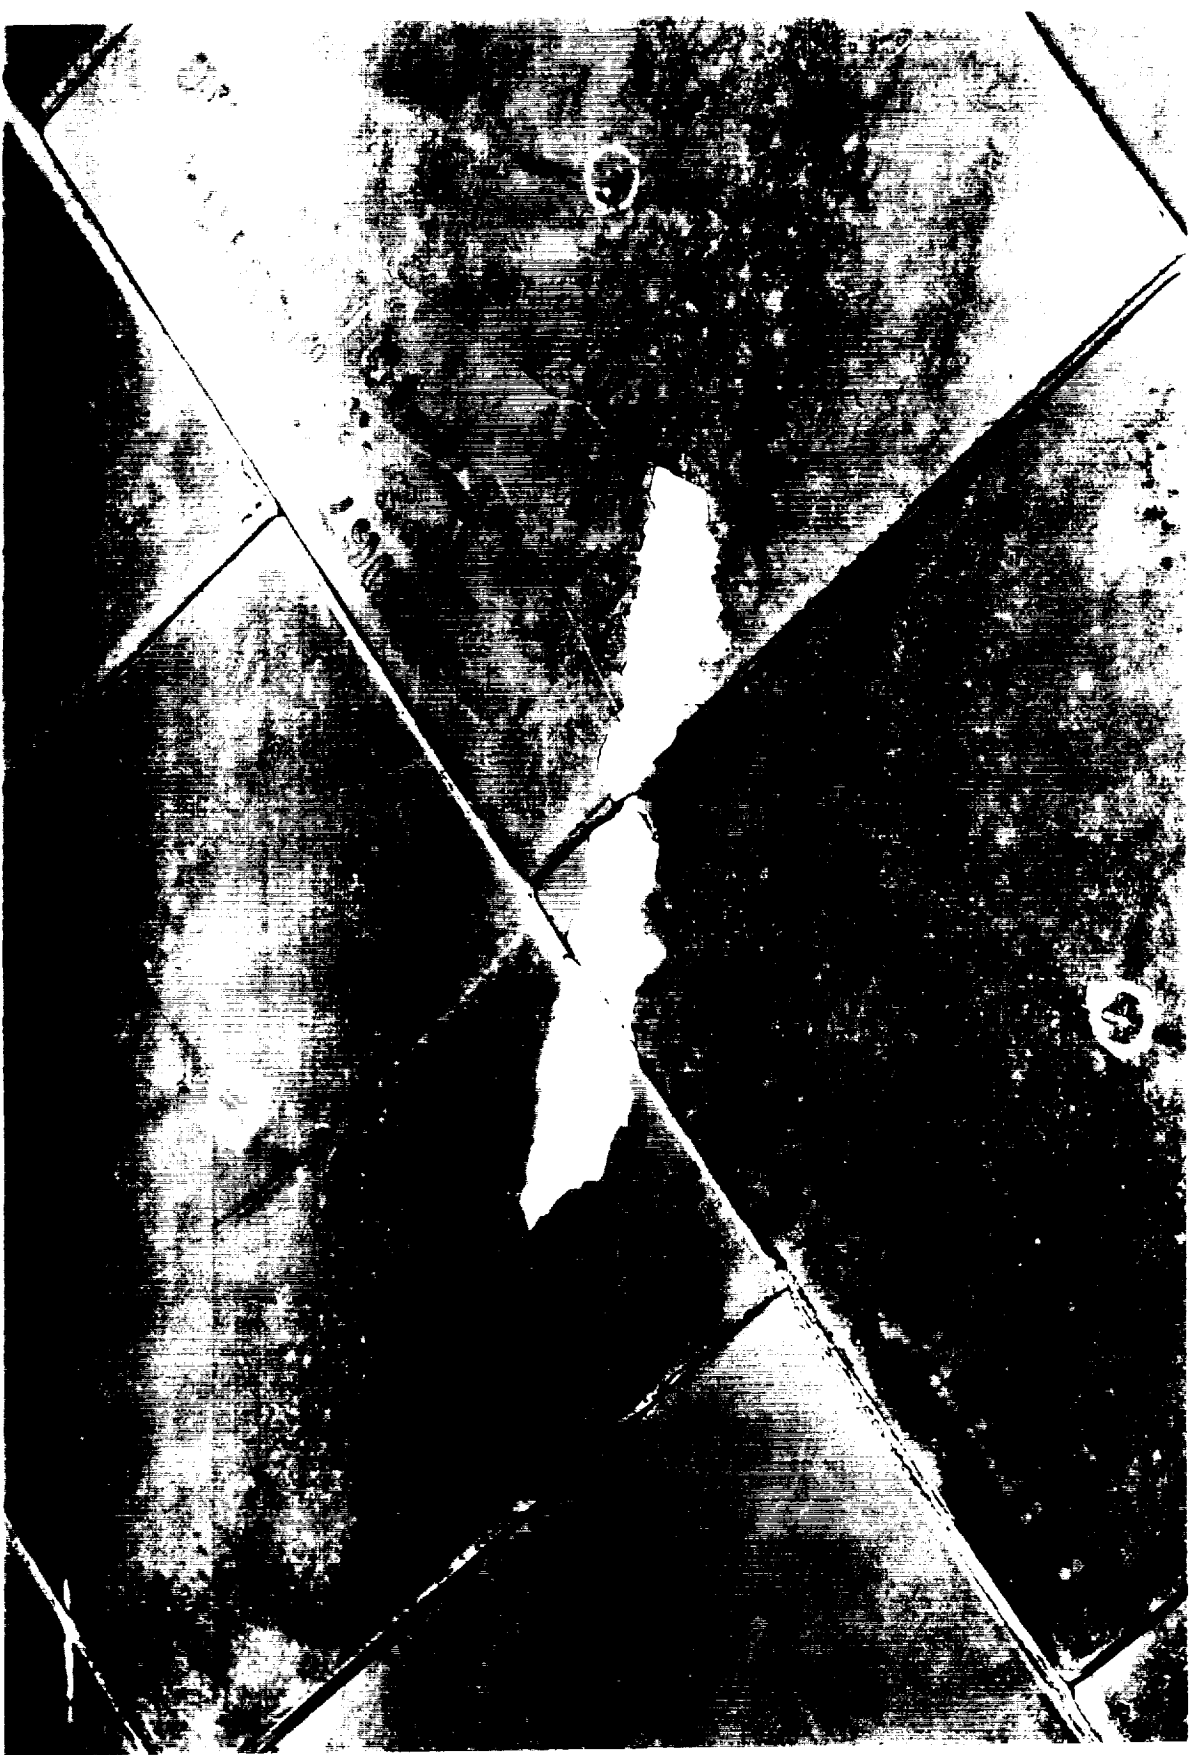
**Photo 21: Damage to Lower Surface Tiles**

The Orbiter lower surface sustained 73 total hits, of which 17 had a major dimension of 1-inch or larger. The largest lower surface tile damage site, located on the right wing outboard of the main landing gear door, measured 6-inches long by 0.50-inch wide by 0.50-inch deep and affected three tiles. The damage cause is believed to be ice from the ET LO2 feedline.

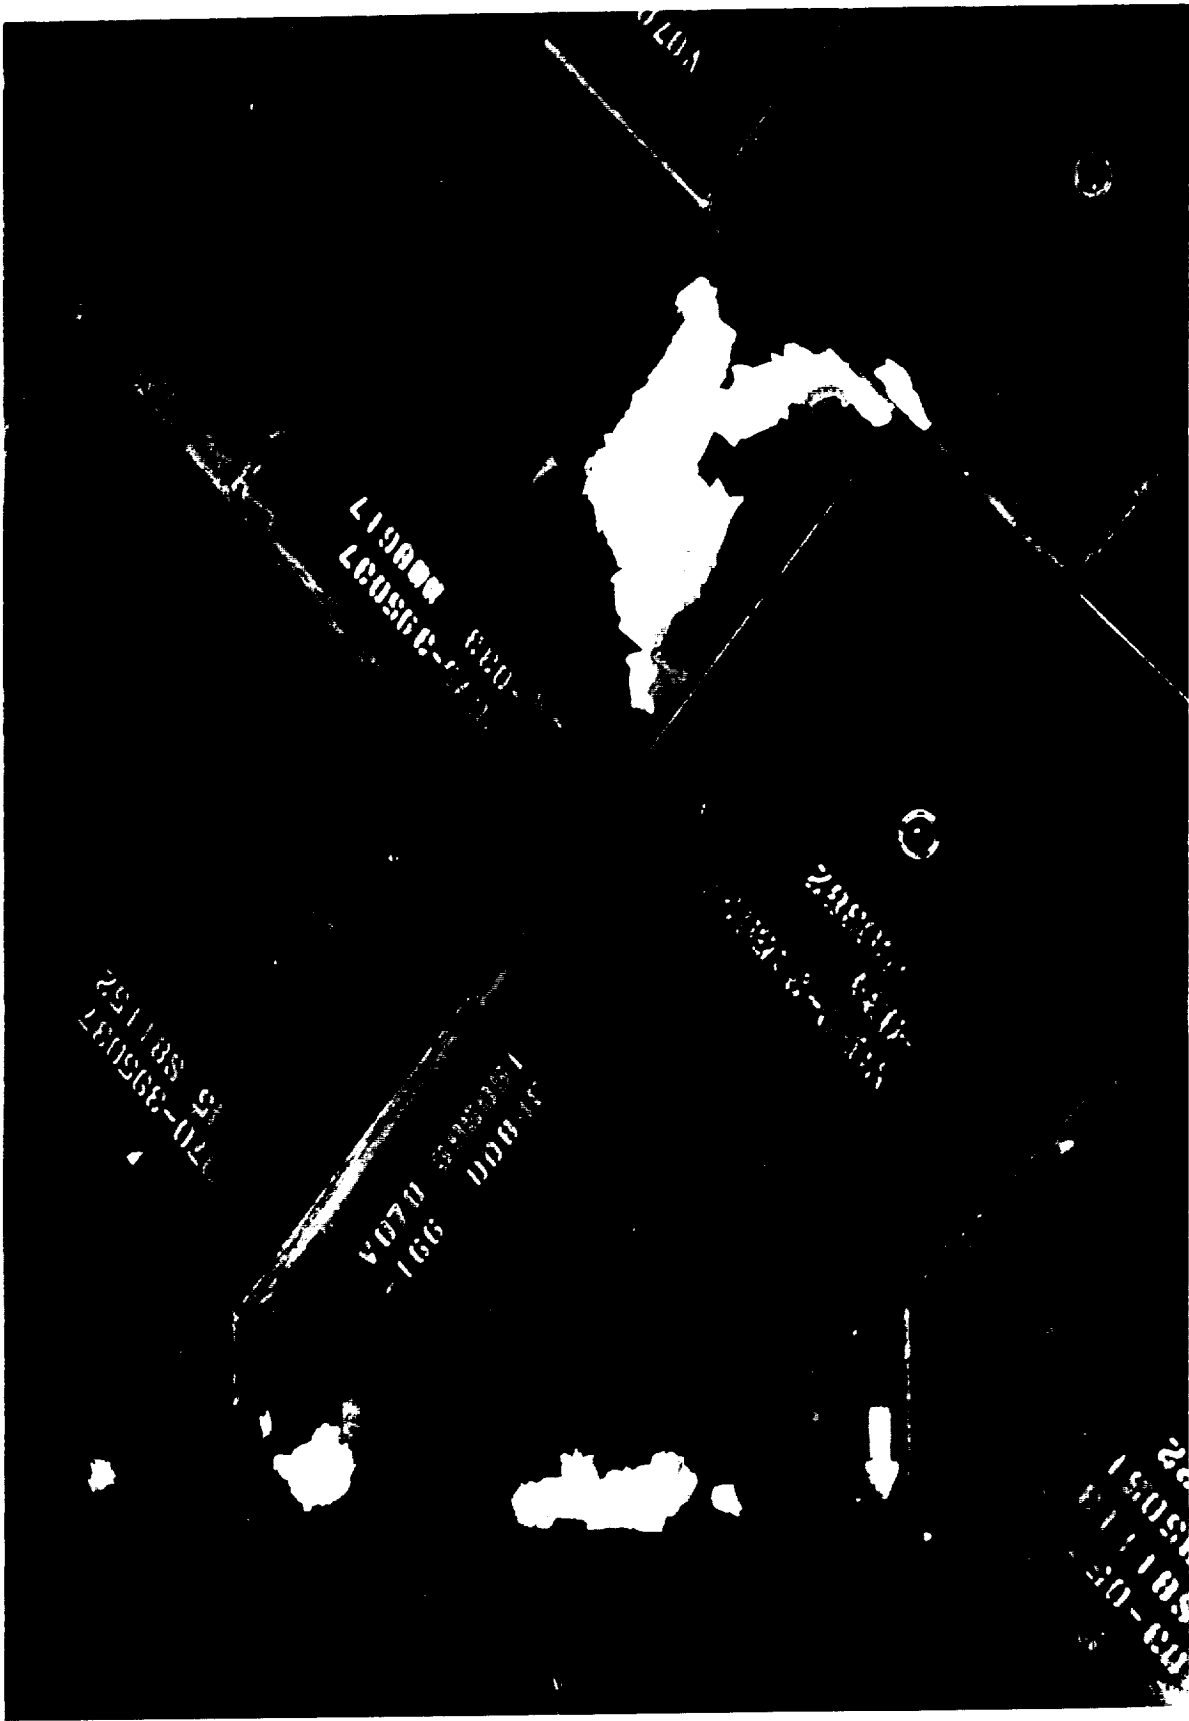
**Photo 22: Lower Surface Tile Damage**

Numerous tile damage sites around the ET/ORB umbilicals were most likely caused by umbilical ice or pieces of the umbilical purge barrier flailing in the airstream and contacting tiles before pulling loose and falling aft.

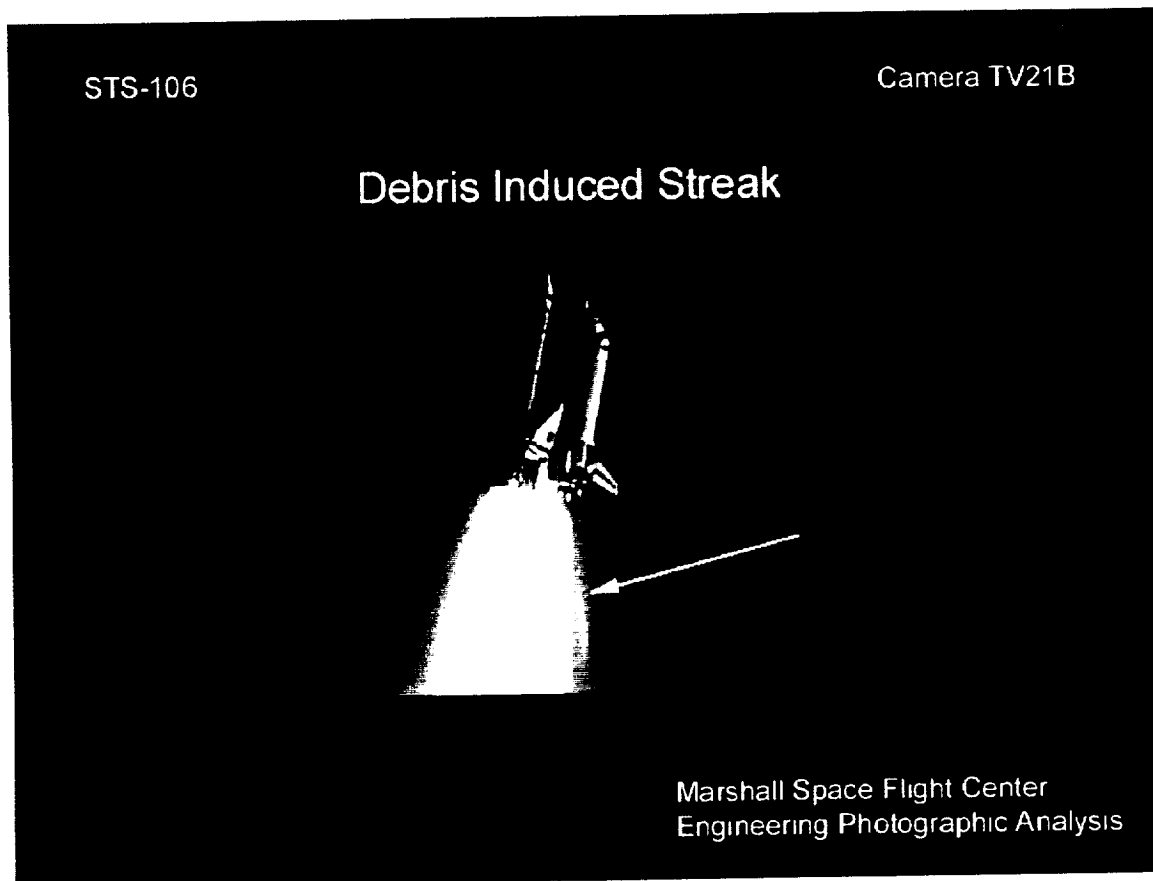
**Figure 4. TV-21B: Debris-Induced Streak**

Several debris-induced streaks were observed in the SSME plumes during this mission. The debris-induced streak in Figure 4 occurred just after the roll maneuver during a time in which the RCS nozzle butcher paper covers, hydrogen fire detectors, and purge barrier material, typically detach from the vehicle due to aerodynamic forces. This type of debris is noted on all missions and resulting plume streaks are common.
